Case History

Balancing an over fire air fan (OFA)

by John Kingham

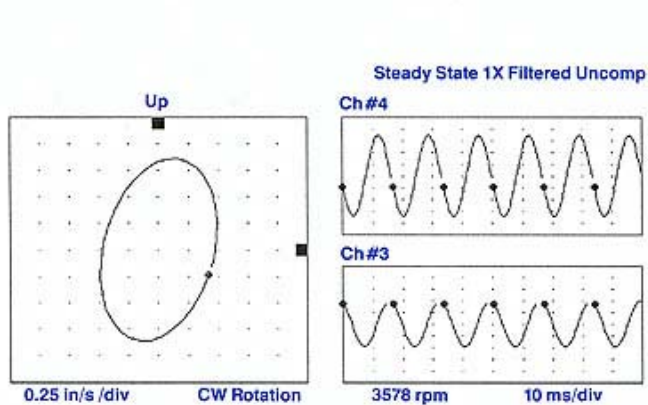
Figure 2
Initial steady state data for Bearing #4

balancing attempt as well. The bearing closest to the fan, bearing #4, had overall amplitudes of 0.68 in/sec (17.27 mm/sec) peak horizontally, and 1.02 in/sec (25.9 mm/sec) peak vertically. The 1X amplitudes were 0.52 in/s (13.2 mm/sec) peak at 331° and .89 in/sec (22.6 mm/sec) peak at 254°, respectively (Figure 2).

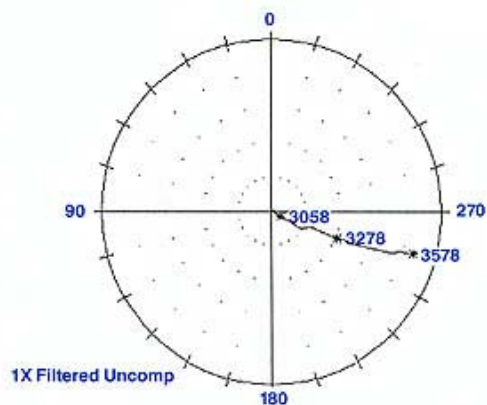
Figure 3
Polar plot of Bearing #4 vertical shutdown

An initial attempt at balancing was made by placing 11 grams of weight at 180° against rotation (AROT) on the inboard wall of the impeller. This weight and location was determined from a review of the Polar plots obtained during a shutdown (Figure 3). These Polar plots also showed the rotor was operating below its first balance resonance. Upon startup, 1X levels were 0.73 in/sec (18.54 mm/sec) peak at 129° and 1.16 in/sec (29.46 mm/sec) peak at 52°. It appeared that we had applied an excessive correction and "pushed" the response vector through zero. Independent calculations, using both the vertical and horizontal response to the calibration weight, indicated that approximately 4.7 grams were needed at 192° (Figure 4).

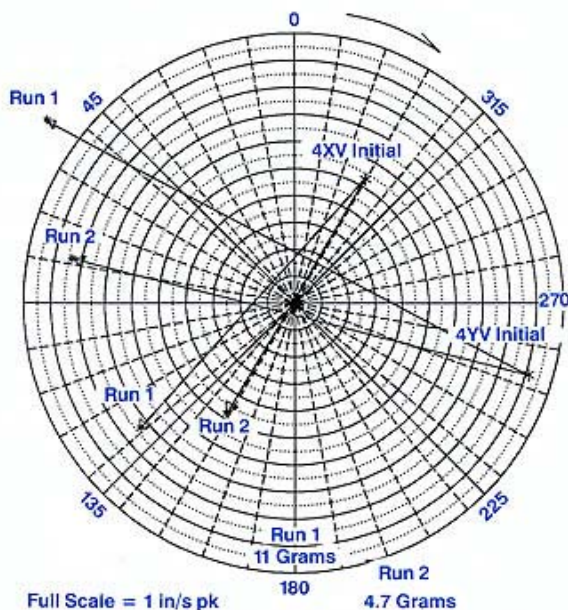
Figure 5
Graphical data after Run 2

levels of 0.48 in/sec (12.19 mm/sec) peak at 149° and 0.84 in/sec (21.34 mm/sec) peak at 79°. It was clearly evident that the fan, for some unknown reason, was not responding in a linear fashion (Figure 5).

The fan would start up with reasonable vibration levels, but shortly after reaching running speed, vibration levels and phase radically changed, accompanied by an audible difference in vibration. No further attempts to balance the fan were made. At this time, a rub was suspected due to the change in amplitudes and the audible vibration.

What at first appeared to be nonlinearities due to massive unbalance appeared now to be due to a rub situation. The fan was inspected for rubs, but none could be found. Another problem

that could have caused these nonlinearities was a looseness in the bearing support system. The #4 bearing cap was removed, and it was determined that about 3 to 5 mils of looseness existed.

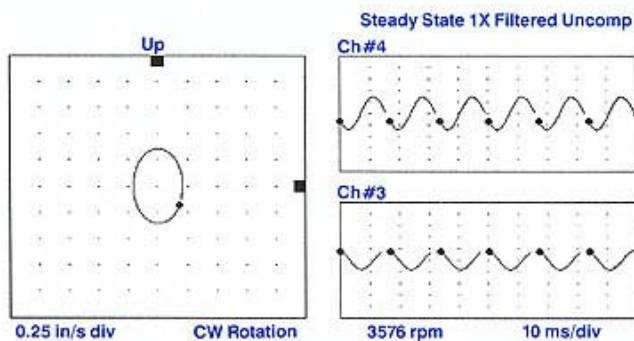
Figure 6
Steady state with 3 mil shim, before final balance

A 3-mil feeler was then placed into the top of the bearing cap, and the fan ran with a **consistent** 1X reading of approximately .21 and .35 in/sec (5.3 and 8.9 mm/sec) peak (Figure 6). It looked like the problem was corrected.

Although the fan could have been rebalanced at this time, operators decided to wait until a good bearing/pillow block could be installed. The fan bearing and pillow block were replaced, and the fan was then successfully trim balanced by the manufacturer's representative.
